Pavement Rehabilitation Schedule
Scale: NONE

Pavement Plan
40' 20' 0 40'

CLIENT:
PROJECT:
DRAWING TITLE:
CLIENT PROJECT NUMBER:
SHEET NUMBER:
P-1

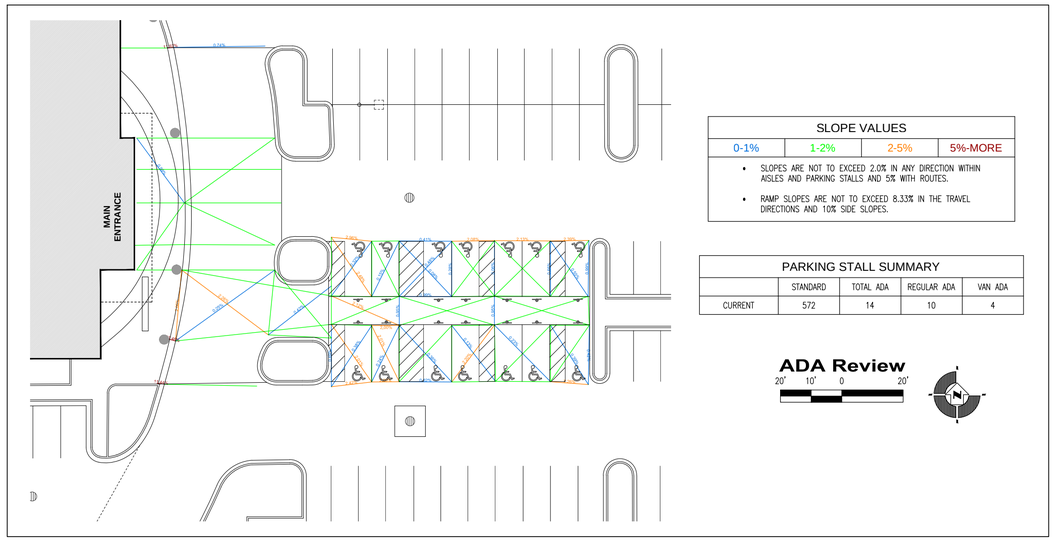
ADA Review
20' 10' 0 20'

- SLOPES ARE NOT TO EXCEED 2.0% IN ANY DIRECTION WITHIN AISLES AND PARKING STALLS AND 5% WITH ROUTES.
- RAMP SLOPES ARE NOT TO EXCEED 8.33% IN THE TRAVEL DIRECTIONS AND 10% SIDE SLOPES.

PARKING STALL SUMMARY				
	STANDARD	TOTAL ADA	REGULAR ADA	VAN ADA
CURRENT	572	14	10	4

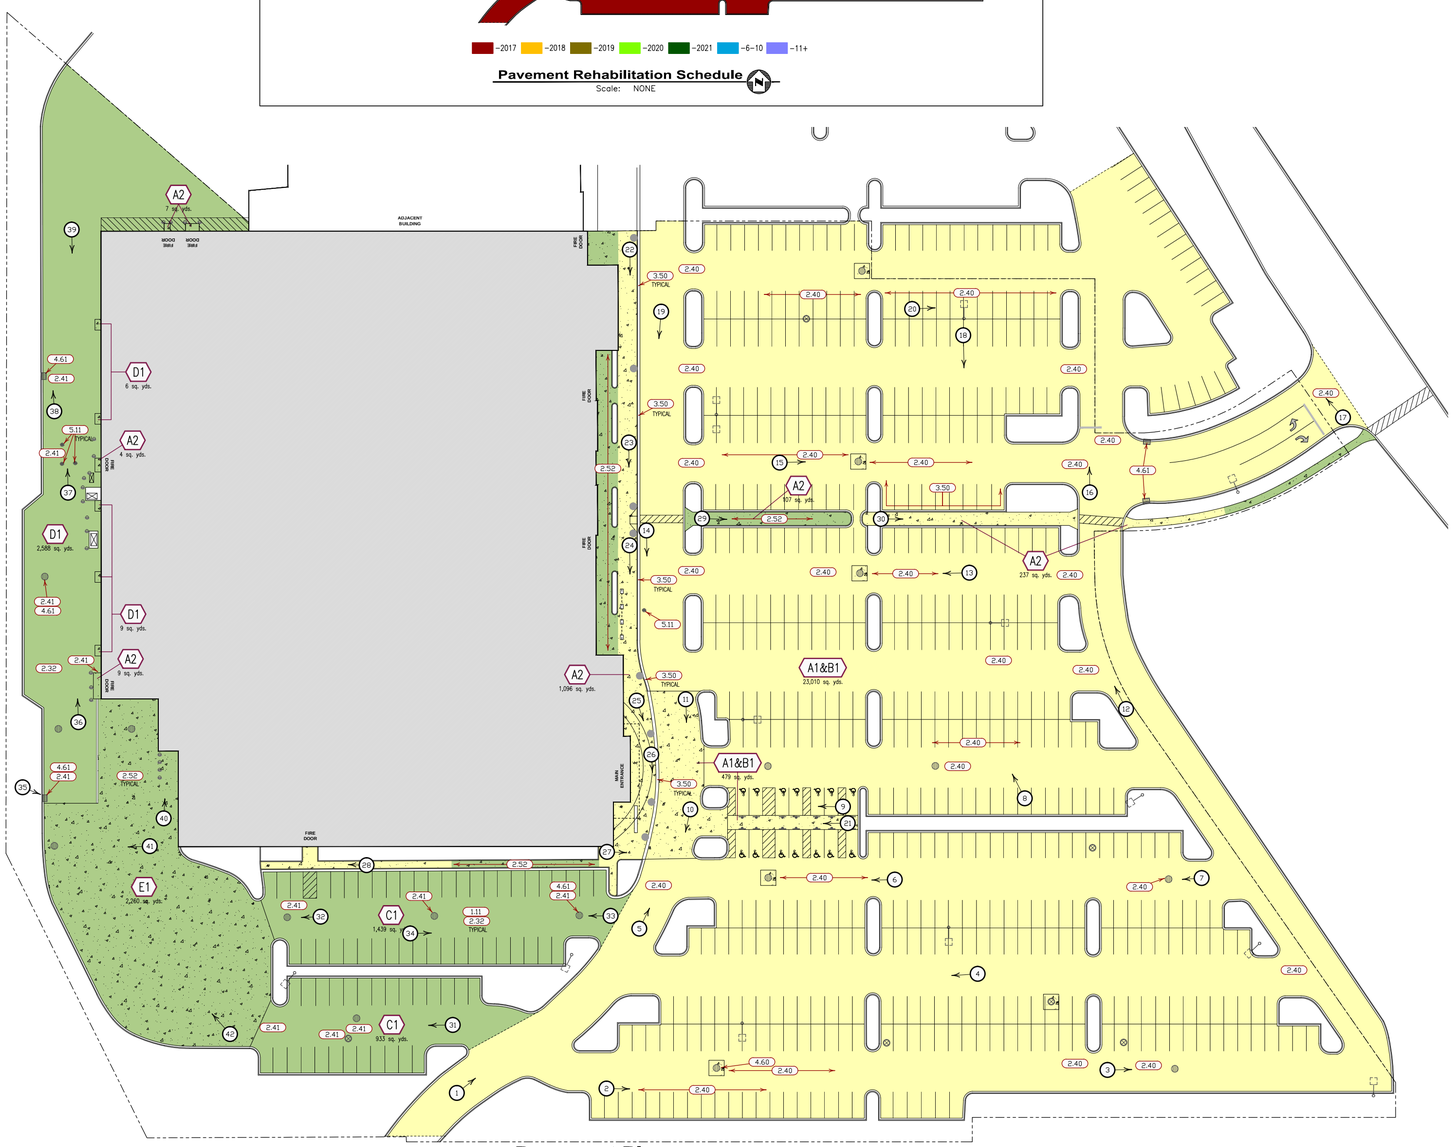
PAVEMENT CONDITIONS, SURFACE DRAINAGE, PONDING AND OTHER DEFICIENCIES OBSERVED BY JOHN DOE AND WERE UNDER DRY PAVEMENT CONDITIONS.
